## **BOS 200® Innovative Bioremediation Approach Implemented in Complex Karst Geology to Treat LNAPL Releasing from Seeps to a Creek and Residential Properties**

### **Summary**

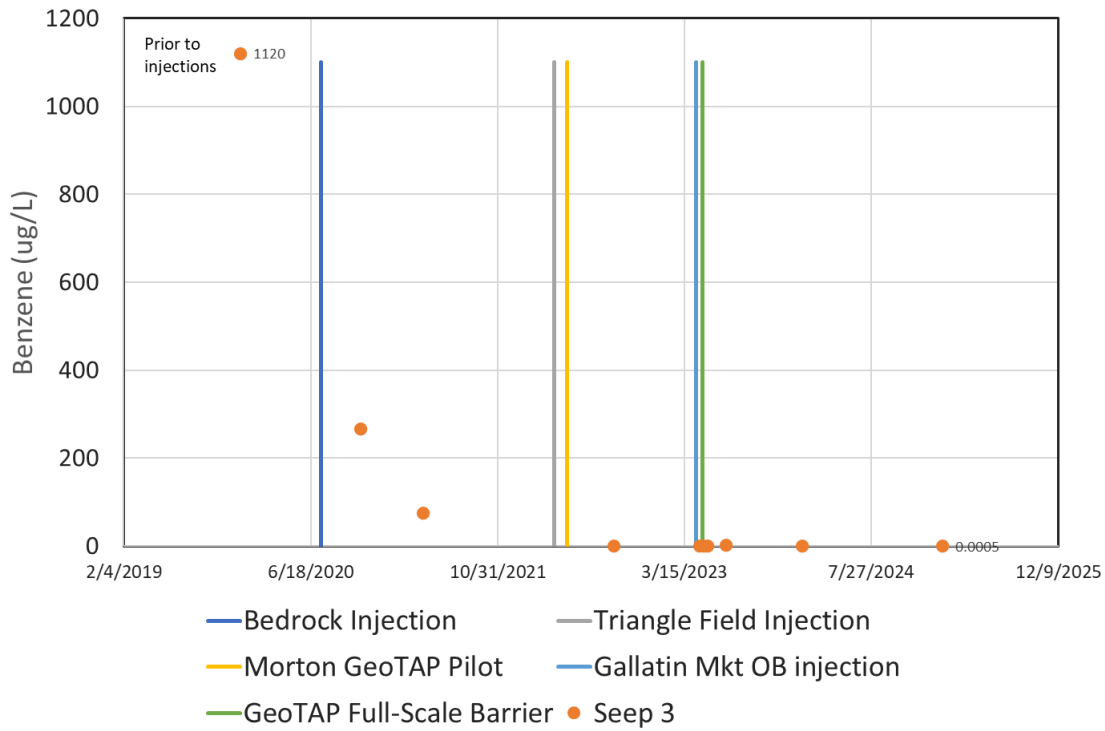
Table 1: Benzene versus Time

### Seep 3 Gallatin

1. LNAPL discharging from the seeps and petroleum odors in the Greenway have been eliminated, the green space has been returned to pre-release conditions
2. Dissolved BTEX constituents in groundwater have been reduced to below Federal MCLs in all three areas
